ALUMINUM ALLOY 2319 WELD WIRE

INVESTIGATION

NSP-64-35

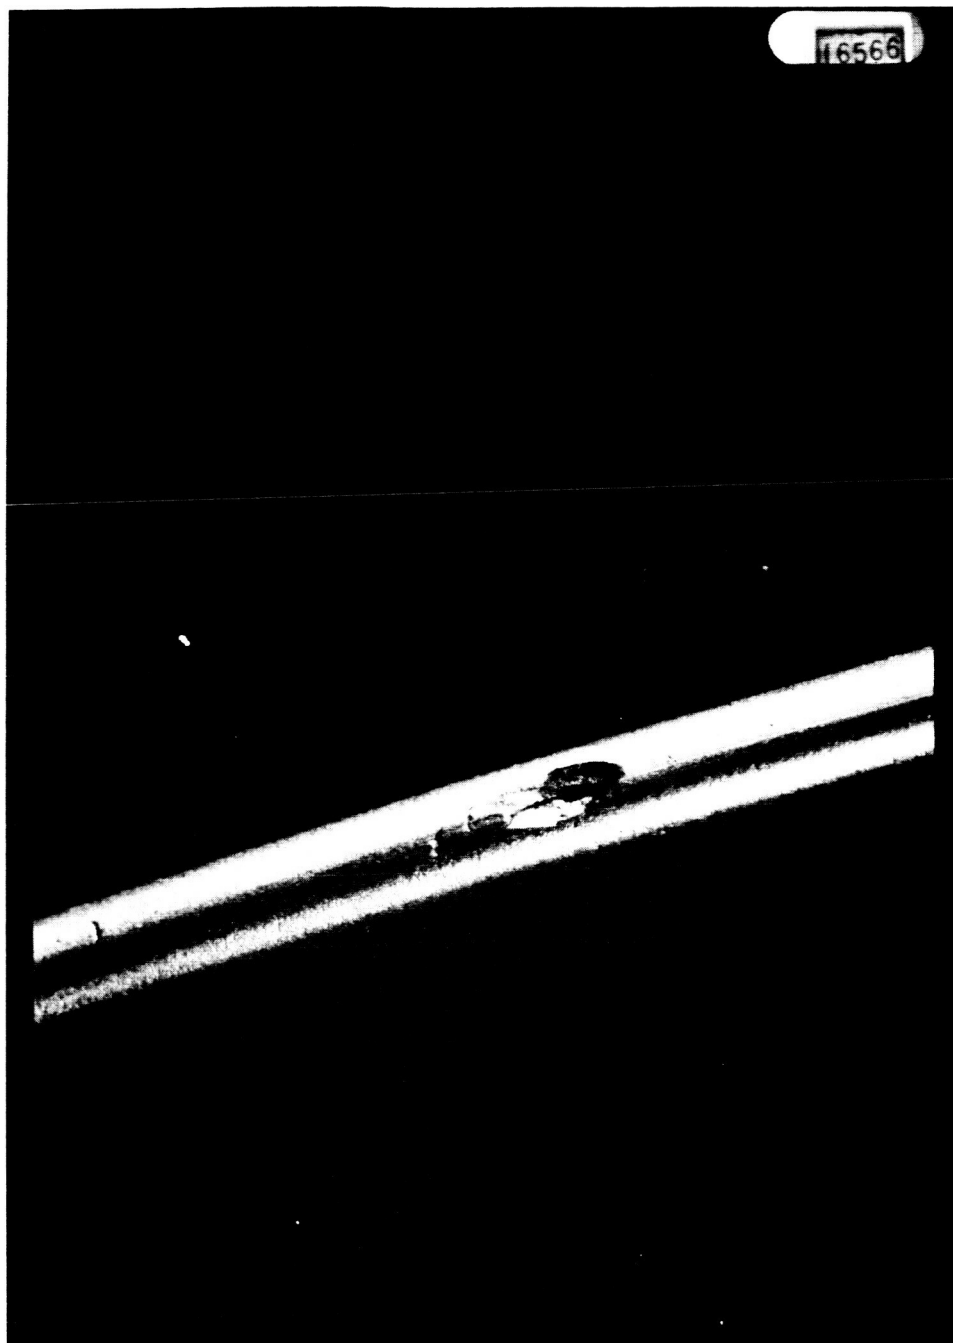
Several surface defects typified in Figure 1, were isolated from two spools of 1/16 inch diameter 2319 weld wire. The wire and wire feed system was thoroughly cleaned to eliminate the possibility of residual contamination entering the weld puddle. The weld parameters were established to produce a drop-through weld on .375 plate. The bead-through-plate weld was utilized to eliminate the influence of joint cleanliness variation on weld quality. Both sides of the plate were scraped immediately prior to welding. The welds were made with 300 amperes, 11.8 arc volts, Helium gas, 9 ipm travel, 63 ipm wire feed in a stake weld fixture.

FIGURE 1 Surface defect in 2319 weld wire. 17K
